Testing **H**ydrogen admixture for **G**as Applications

Long term effect of H₂ on appliances tested

Report by GWI and DGC for the THyGA Consortium

Deliverable:	D3.9
Status:	Final, 10 th of May 2023
Dissemination level:	PU - Public

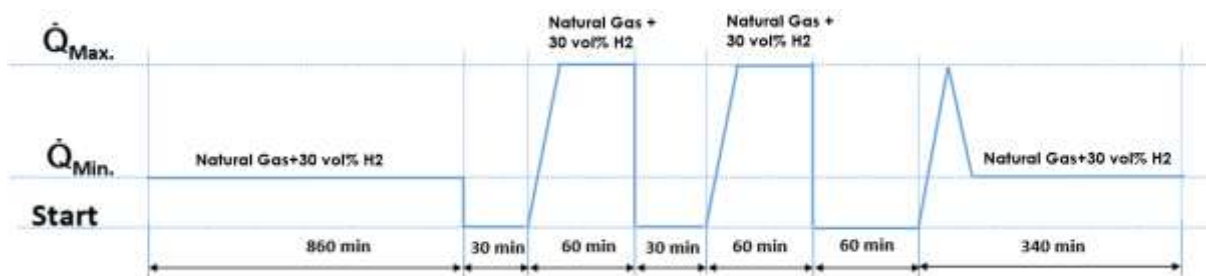
Figure 2: 24-hour load profile applied for long term tests on 6 out of 7 days per week.

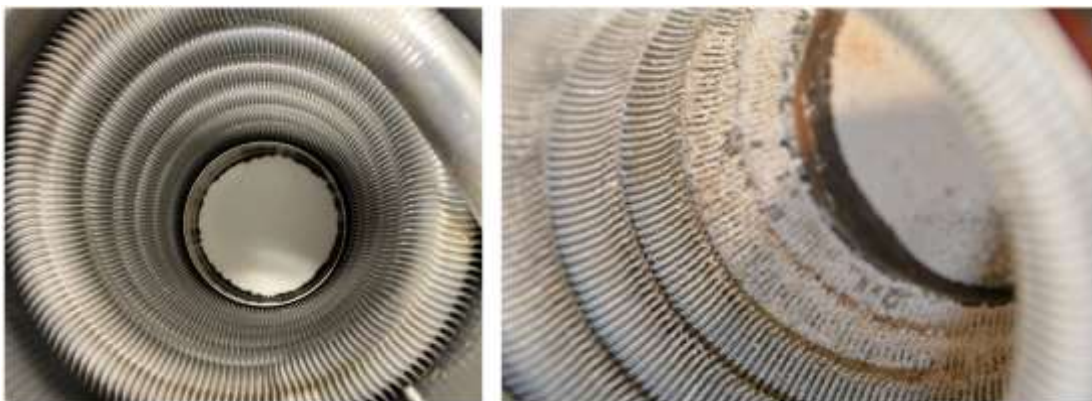
As can be seen in Figure 4 and Figure 5, the heat exchanger surfaces show some deposits after the long-term tests. This observation however corresponds well with the experiences from comparable used appliances with natural gas. The same holds true for the visual appearance of the burner surfaces, which are shown in Figure 6 for boiler 2. Minor deposits and discolouration of material are fully in line with expectations in view of the long operation times of the appliances. These findings were accordingly confirmed with the manufacturers.

Figure 5: Boiler 2 – Heat exchanger before (left) and after (right) long term test. The observed deposits correspond to typical natural gas operation.

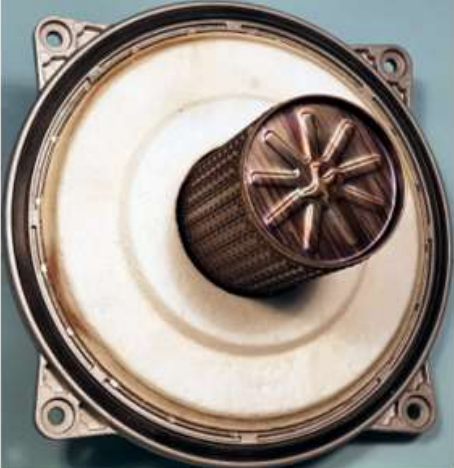
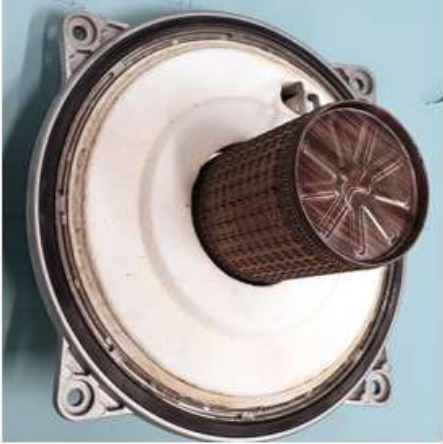
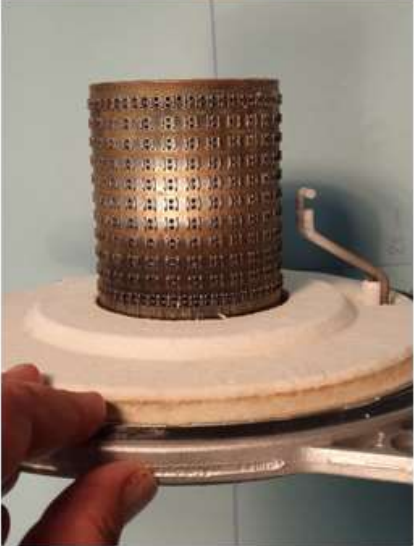
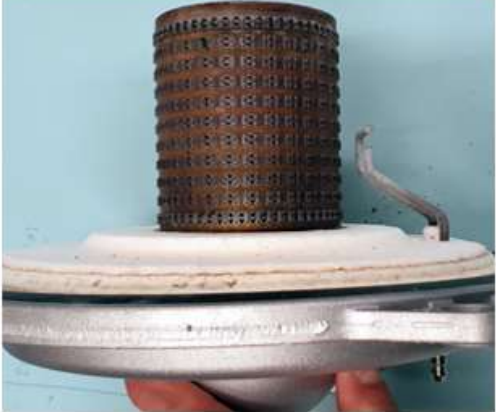
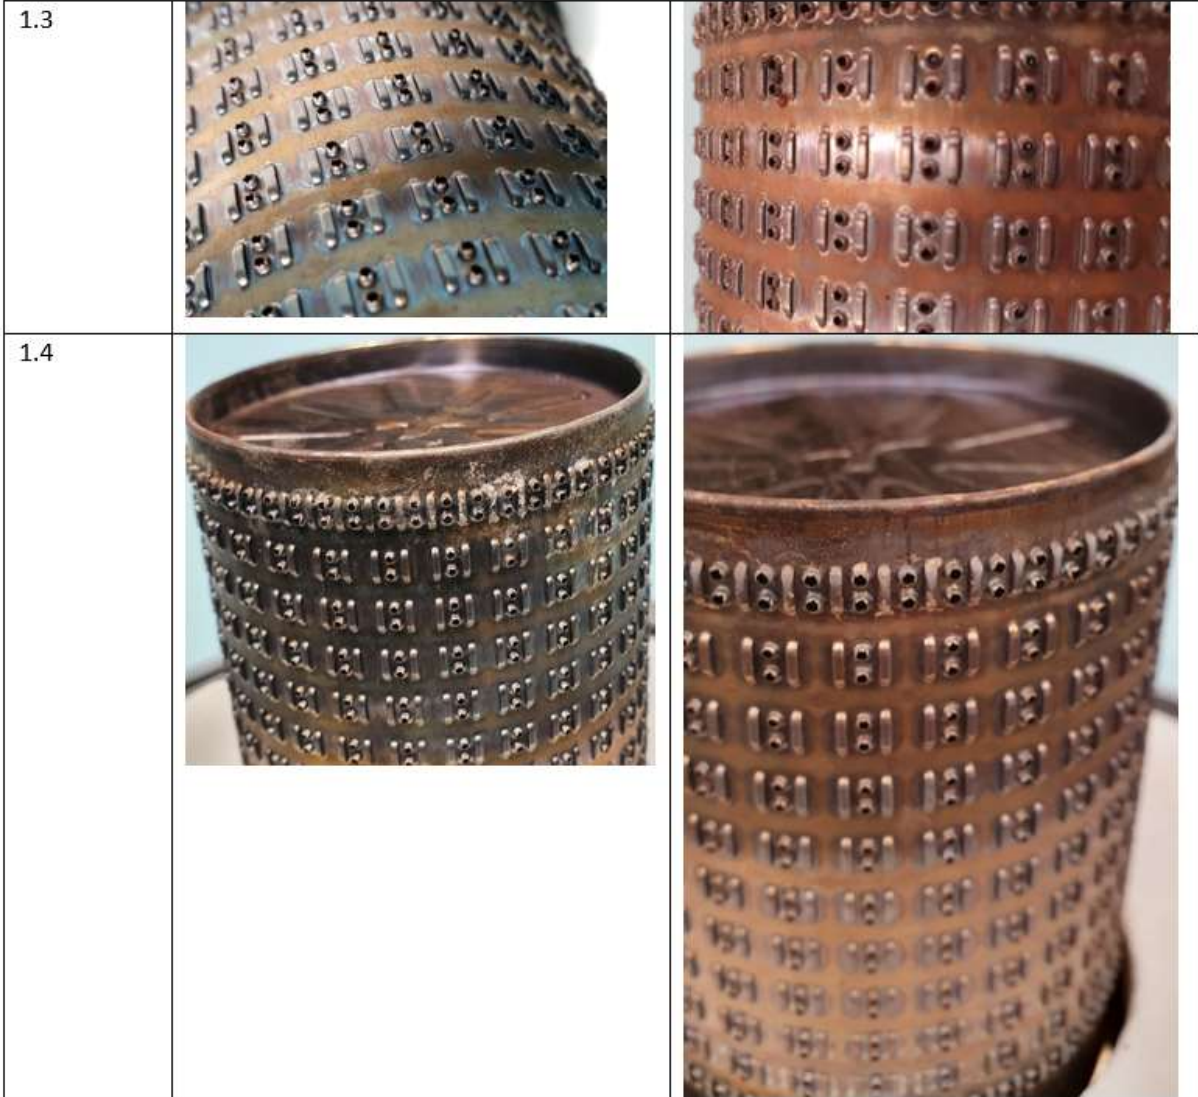
Figure 16: Pictures of boiler 1 Burner (D4)

The burner itself is more orange and there is deposit around the heat exchanger. Following discussion within WP3 and manufacturers, it was concluded that this is due to air pollution that remains attached to the coils at high temperature. It is a normal behaviour also with NG or LPG and is not linked to H₂. Bigger is the pollution or the quantity of dust in the air and bigger is this black/brown deposit in the exchanger.

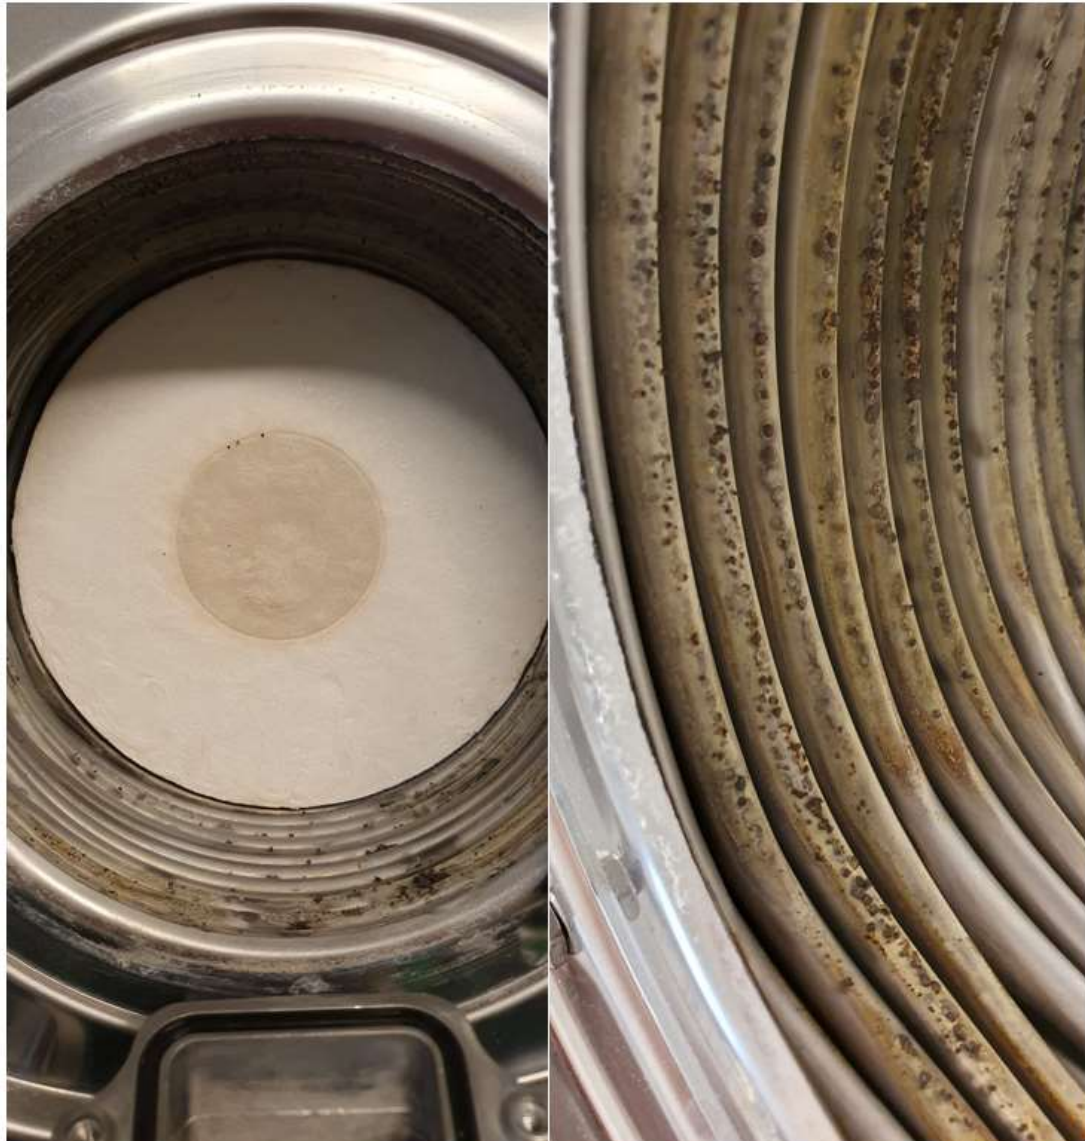
Figure 17: Front and closeup view of boiler 1 heat exchanger (D4)

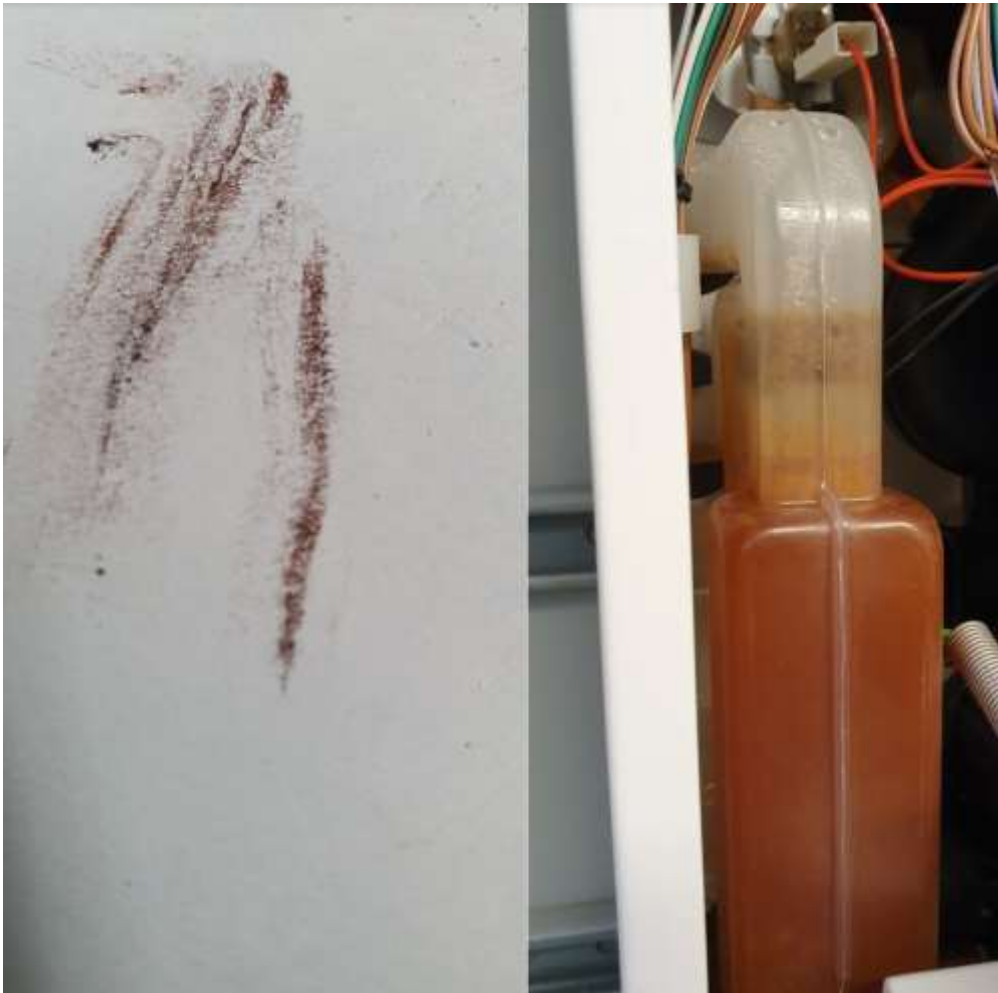
Figure 19: Deposit in boiler 1 (D4) spread on paper on the left, deposit in the boiler (“condensate reservoir”) on the right.

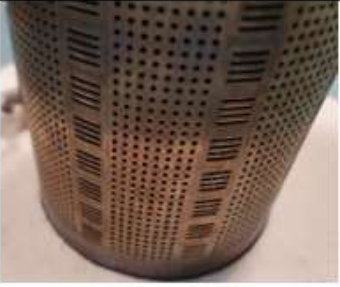
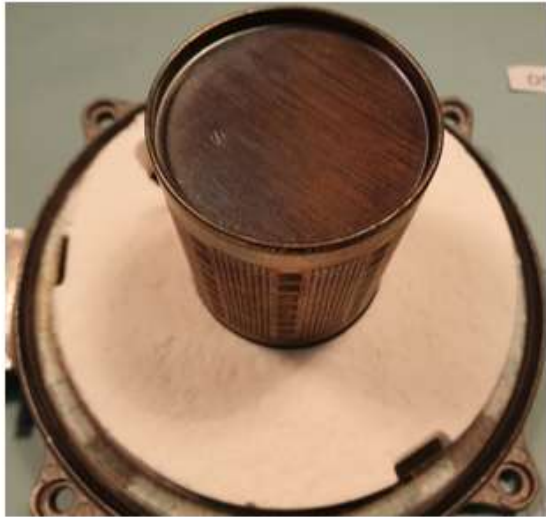
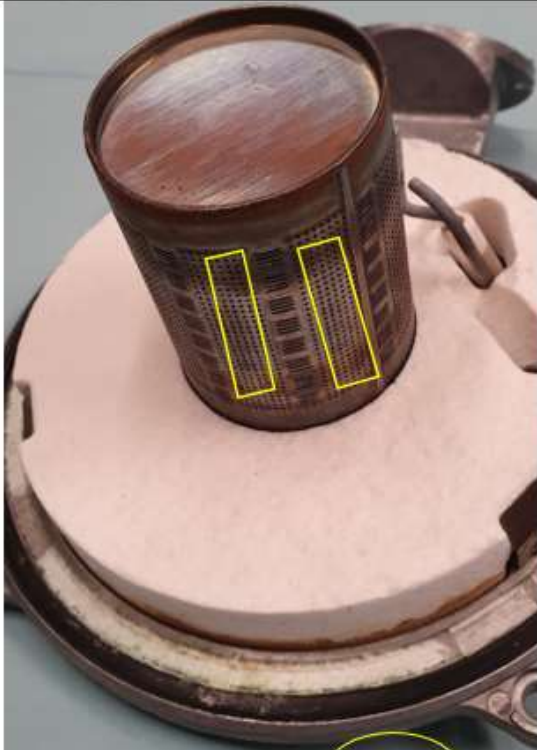
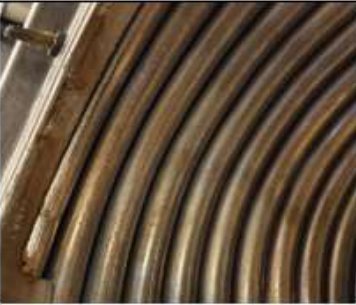
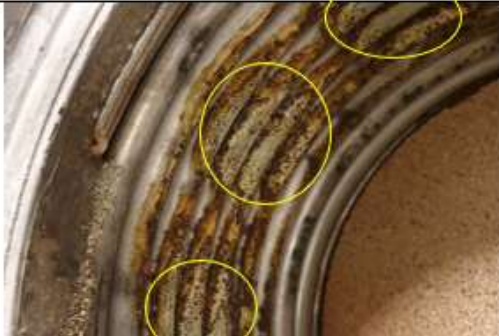
Figure 20: Pictures of boiler 2 (D5)

Little difference on the heat exchanger itself. We also observed a heavy deposit inside, probably also due to air pollution. Deposit alternates green circles and rust, corresponding to the burner structure (picture 2.4) with the little holes of the burner that are separated by bigger ones (yellow circles on pictures 2.4, 2.5 and 2.6). There is still more rust on top.

The insulation material is chipped (Figure 20, picture 2.2).

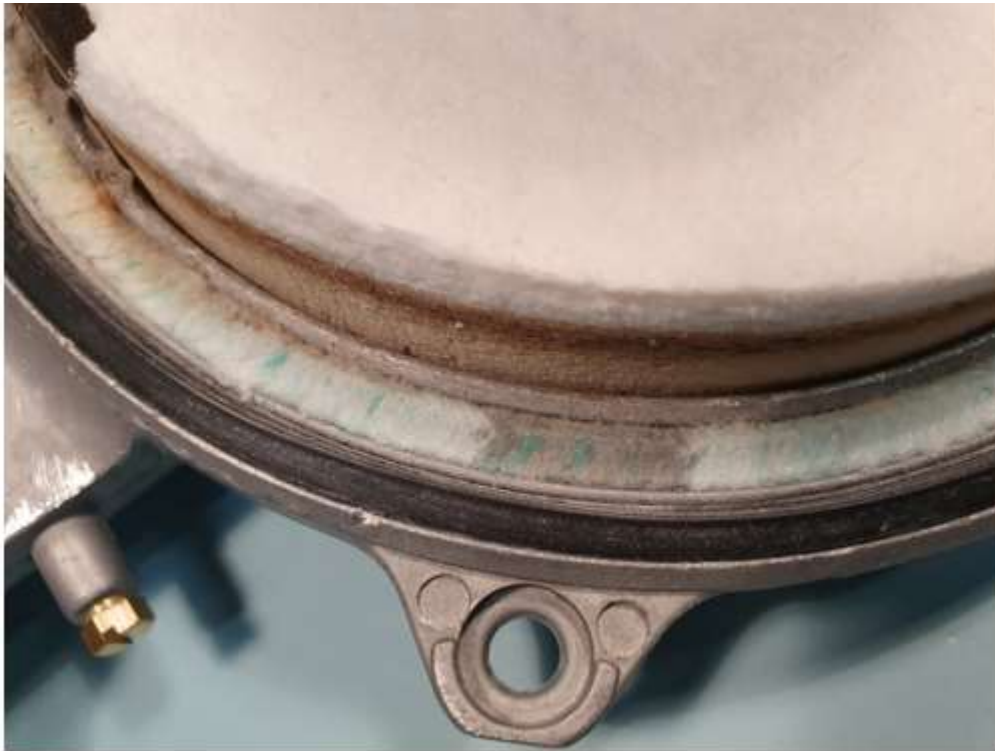
Figure 22: Closeup of isolation of boiler 2 (D5)

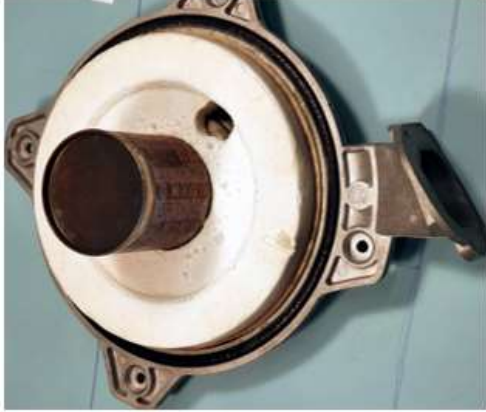
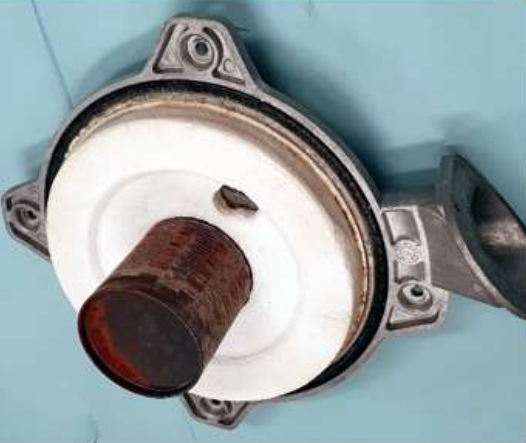
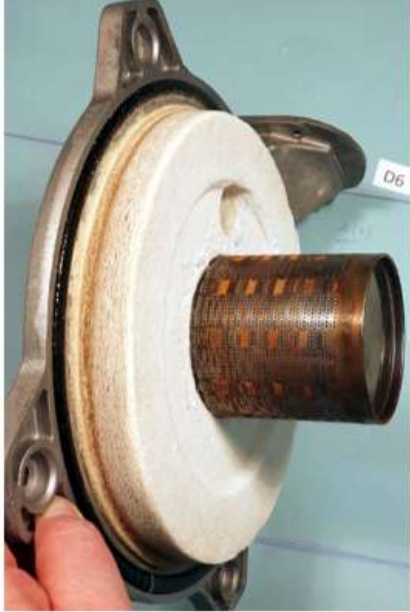
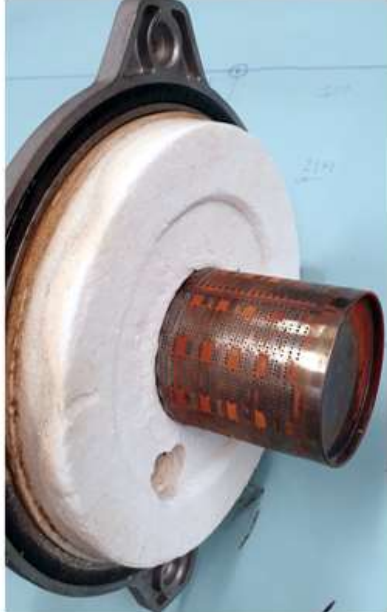
Ref	Before	After
3.1

There is more rust on the burner (picture 3.3) and deposit around. This time it seems to be corroded. We can see on picture 3.5 that the corrosion is not all around, just on specific portions of the cylinder (mostly the top). The reason is unclear so far.

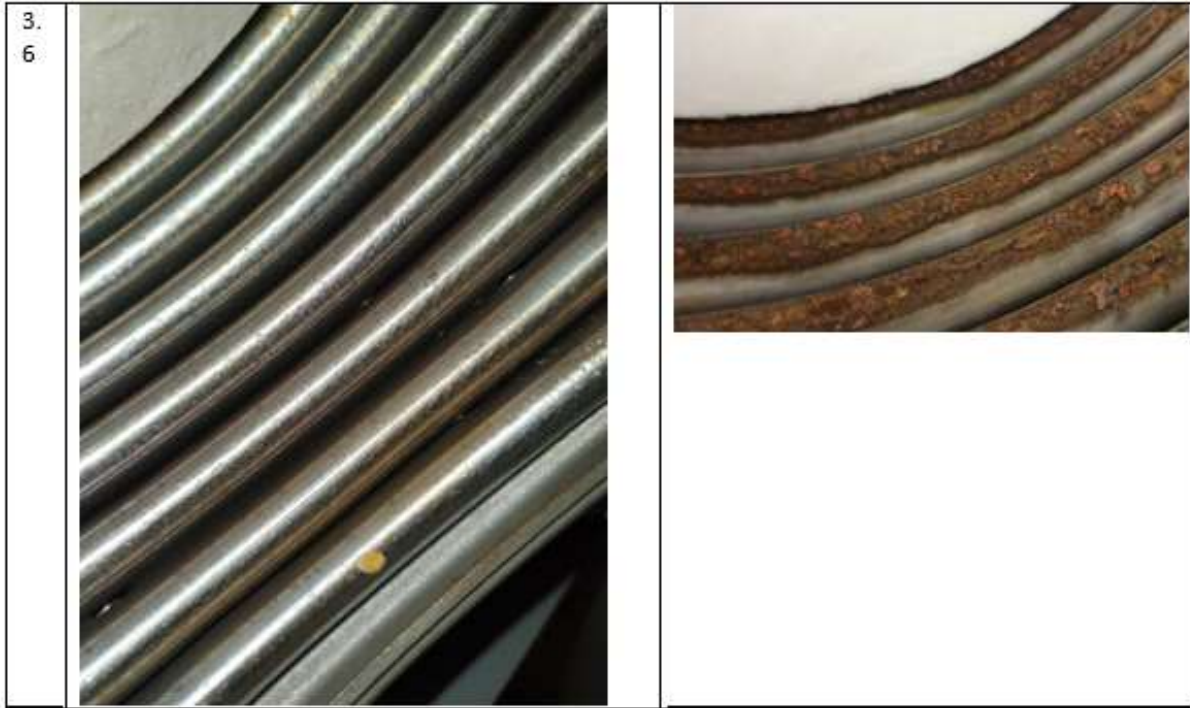
Figure 23: Pictures of boiler 3 (D6)

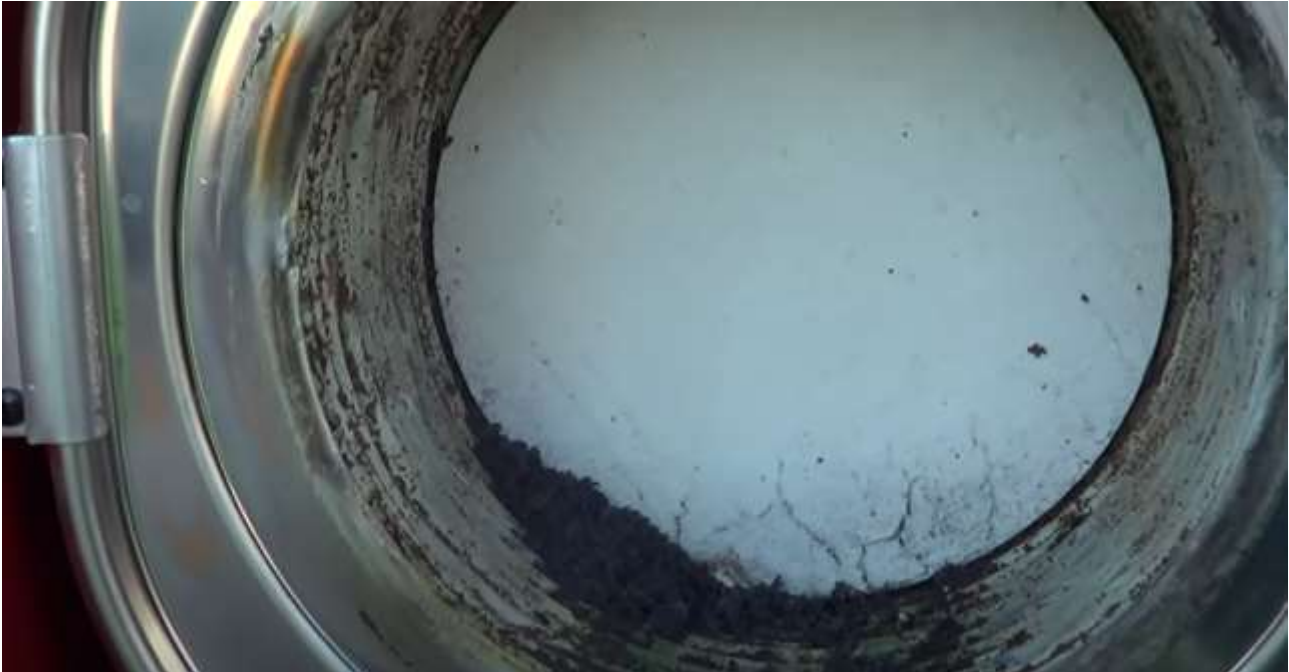
All boilers have a certain amount of deposit/rust. The deposit seems to come from air pollution and is normal (see screenshot from the video of maintenance underneath).

Most of that deposit is on the top of the boilers. This is probably due to the evacuation of the flue gas that happens at the top.

Figure 25: Screenshot from maintenance video of a similar boiler operating with natural gas in field – source: You Tube

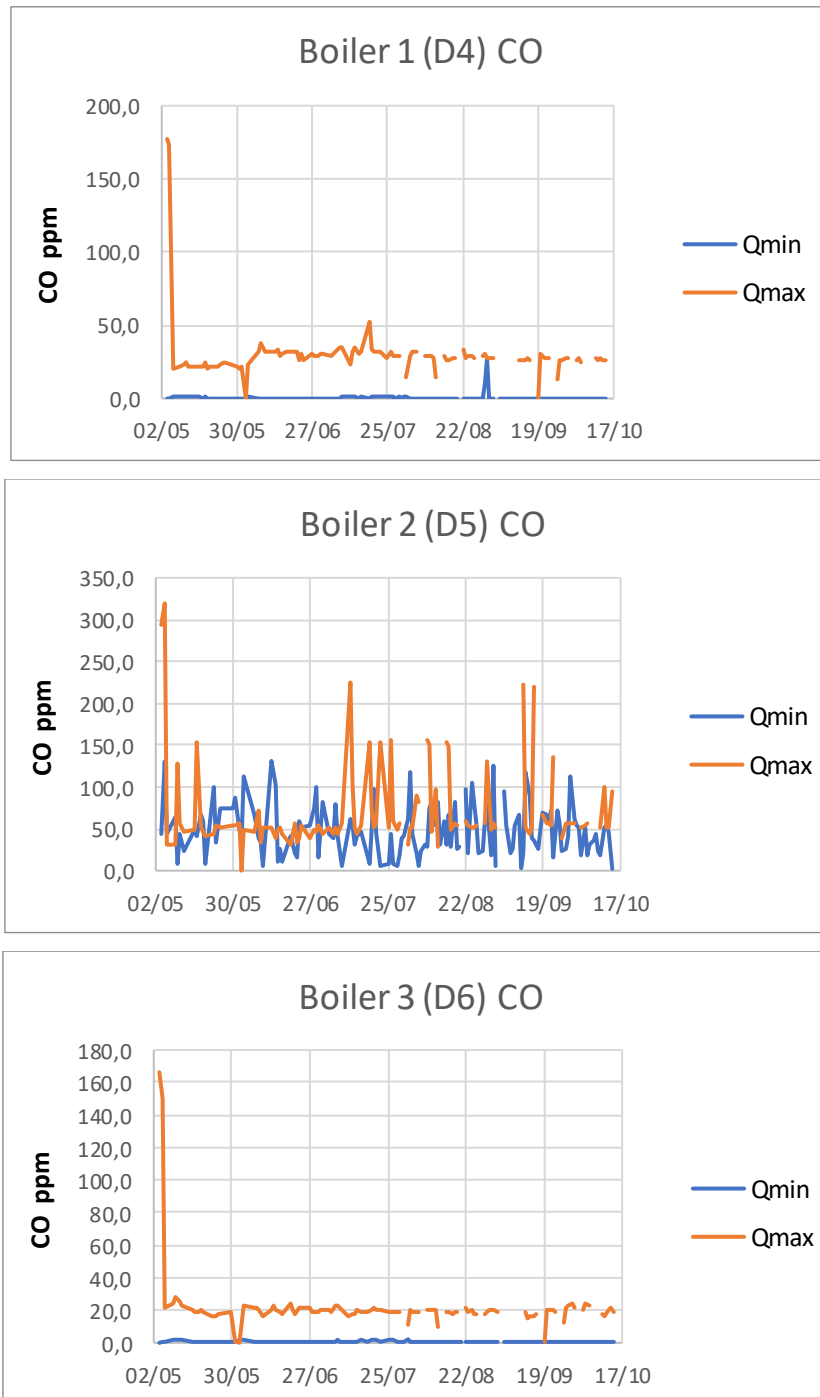
Figure 26: CO emissions for the 3 boilers tested at DGC

We don't see an evolution of the CO during the duration of the test. Peaks for boiler 2 are linked to the boiler operation.

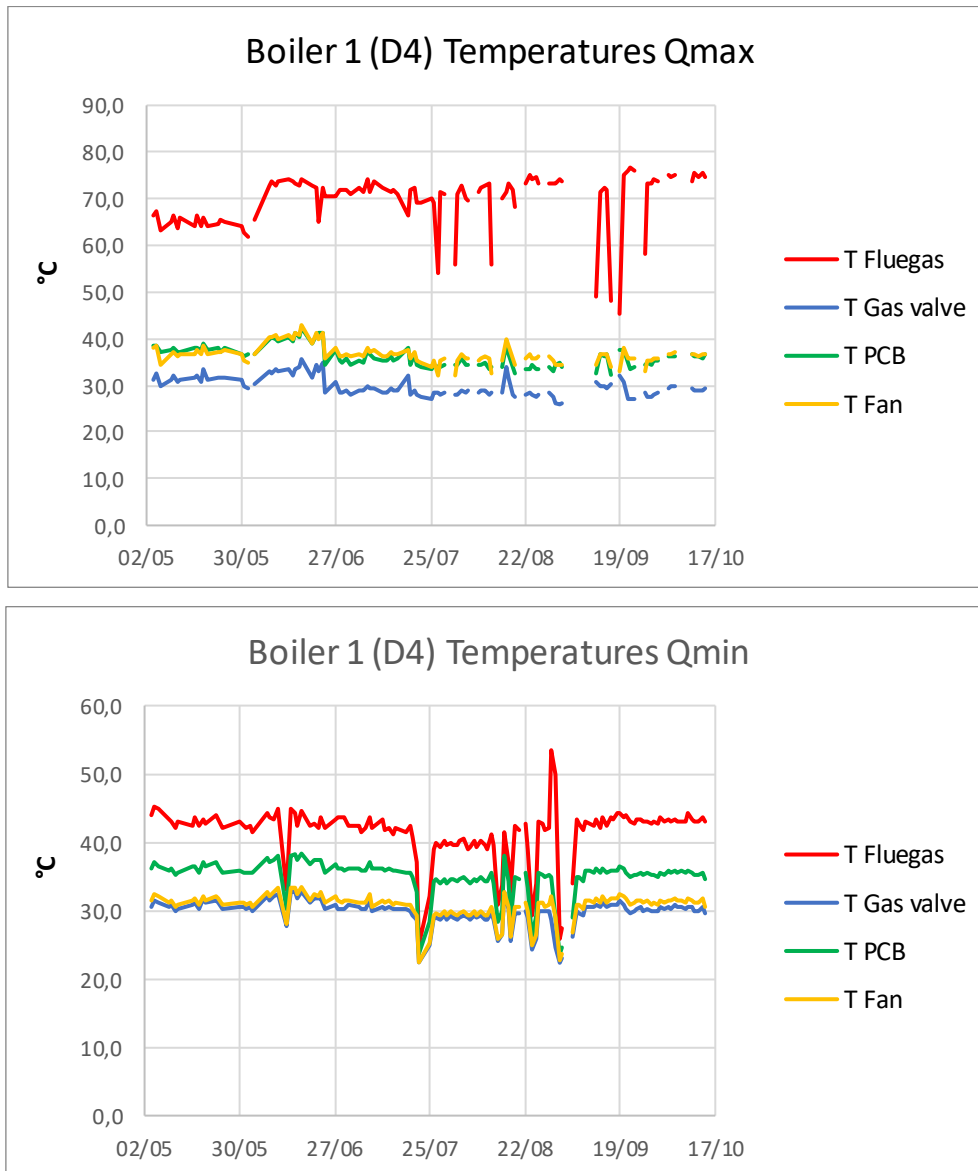
Figure 27: Temperatures evolutions for boiler D4 tested at DGC

For this boiler, we see a sudden increase of the flue gas temperature (about 10 °C) at **Qmax** during the duration of the test (around the 30/05). This is correlated with the increase of heat input, which was changed because the appliance was not actually operating at the nominal **Qmax** before that date. So the heat input was adjusted by the laboratory to correct from this. This has not impacted the result.

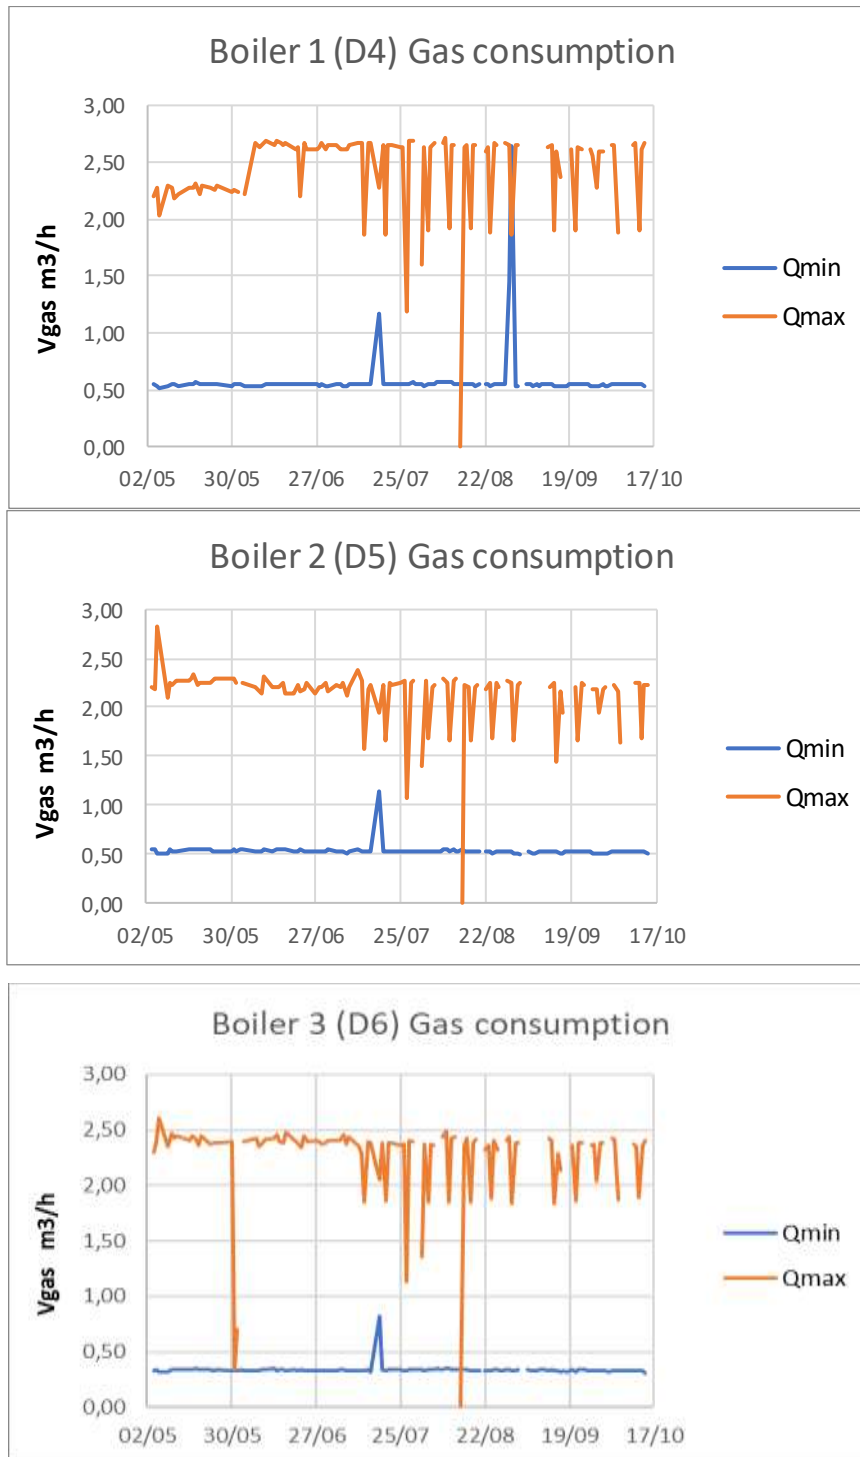
Figure 30: Gas consumption evolutions for the 3 boilers tested at DGC

There is a sudden change in gas consumption for boiler 1 at Qmax because the boiler was previously not functioning at Qmax but at a lower power (wrong setting by mistake).

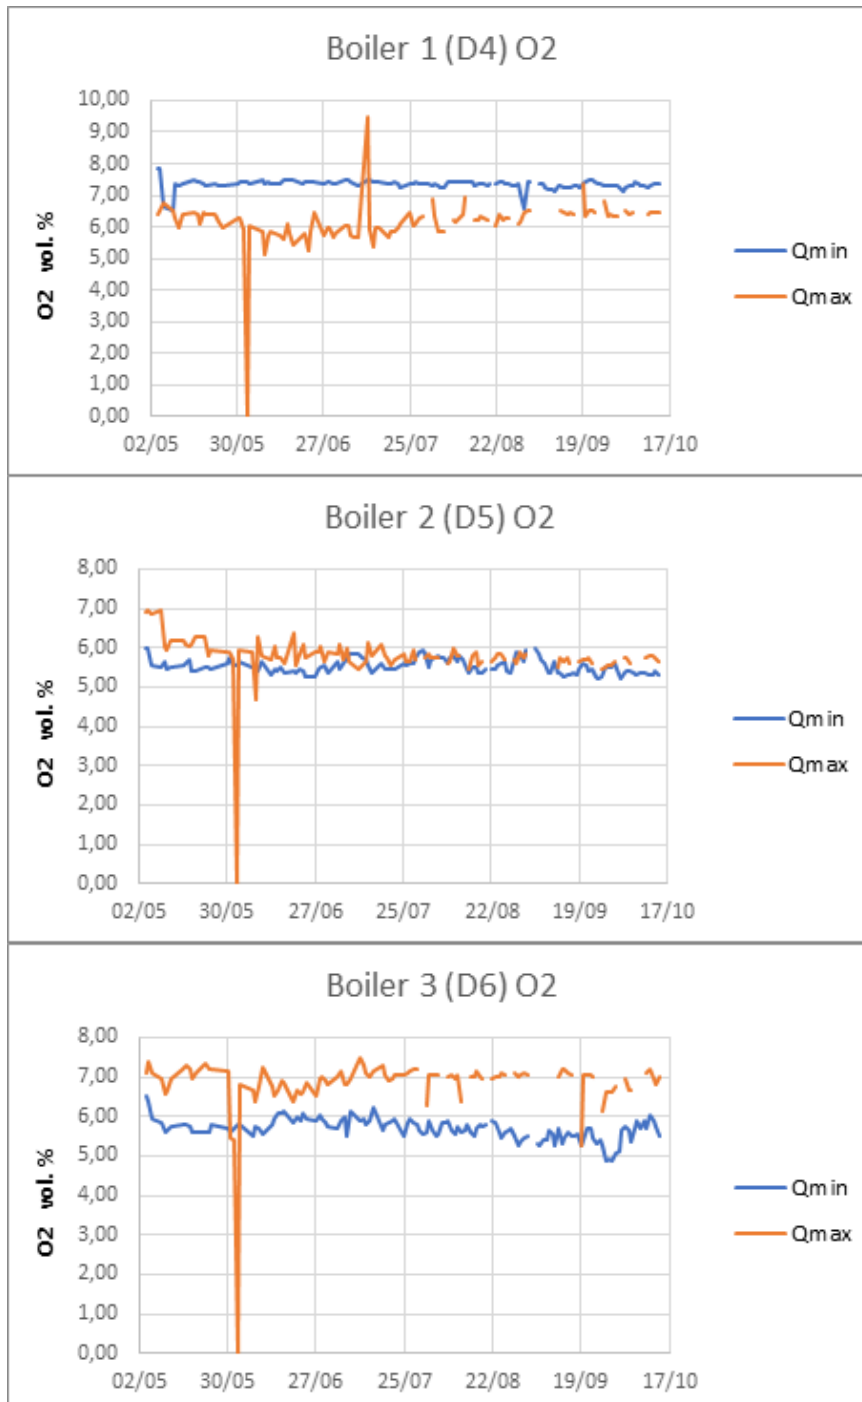
Slight decrease in O₂ for D5, otherwise the levels remained stable.

Figure 31: O₂ levels in the exhaust fumes evolutions for the 3 boilers tested at DGC

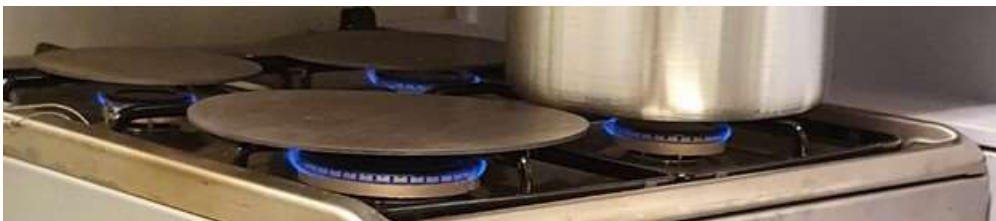
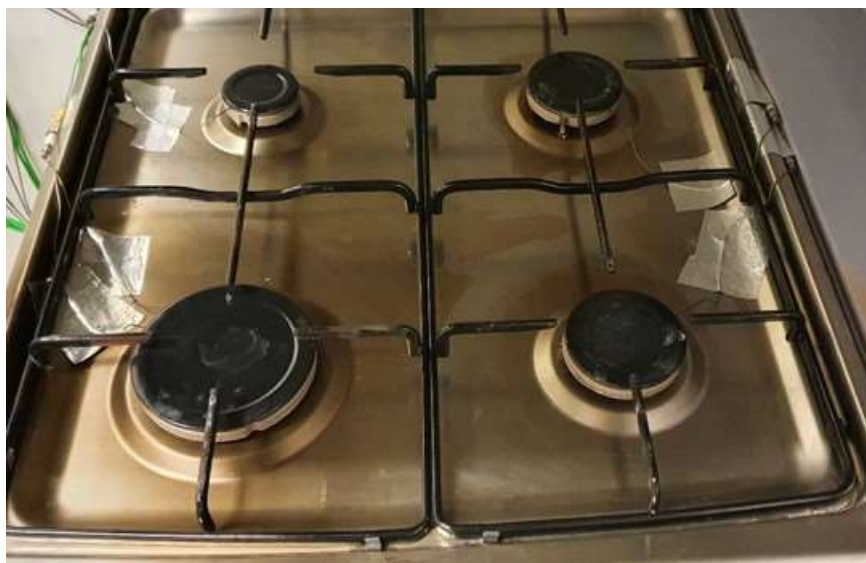
Figure 33: Plates setup above, temperature probes setup underneath

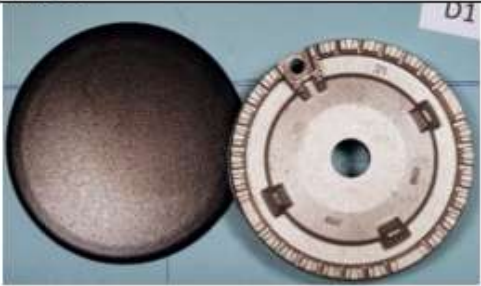
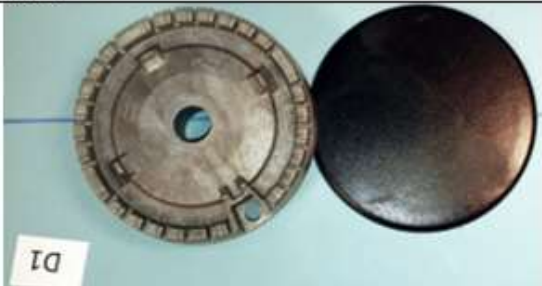
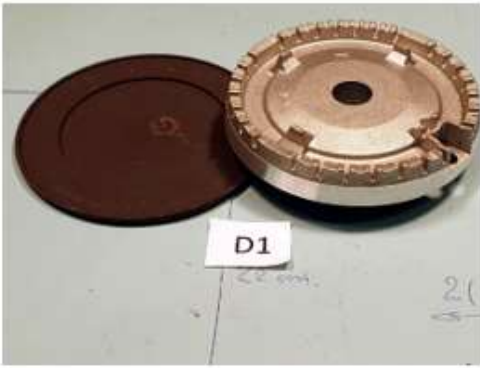
Figure 35: Pictures from cooker 1, burner D1 N°1

Overall, marks of wear can be seen, especially on the burners. Picture D1.2 and Figure 36 show a sort of “petrol” reflection on the metal. Black marks on the sides and on top.

Some water was lost during the operations (from the pot), making the screws rust. The rust on the screws surrounding the ignition pit is uneven.

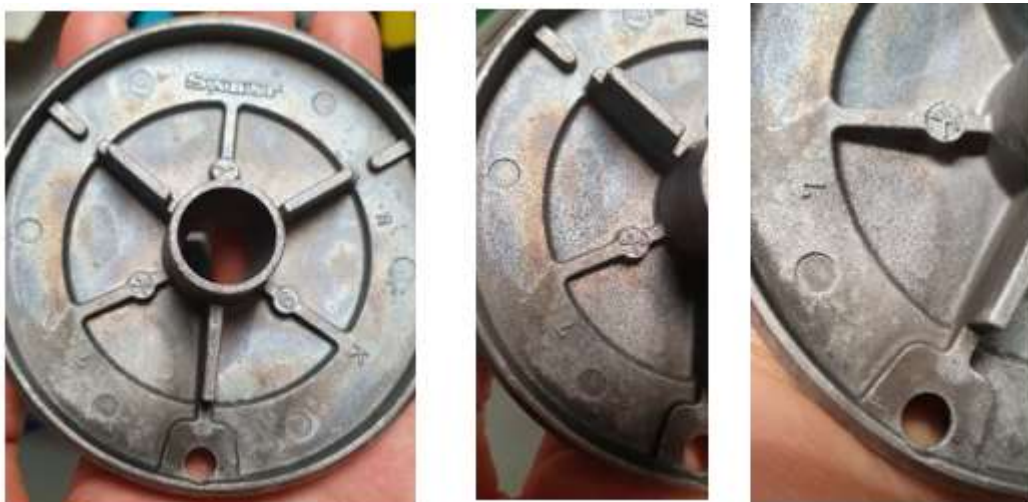
Figure 36: Pictures from cooker 1, burner D1 N°2

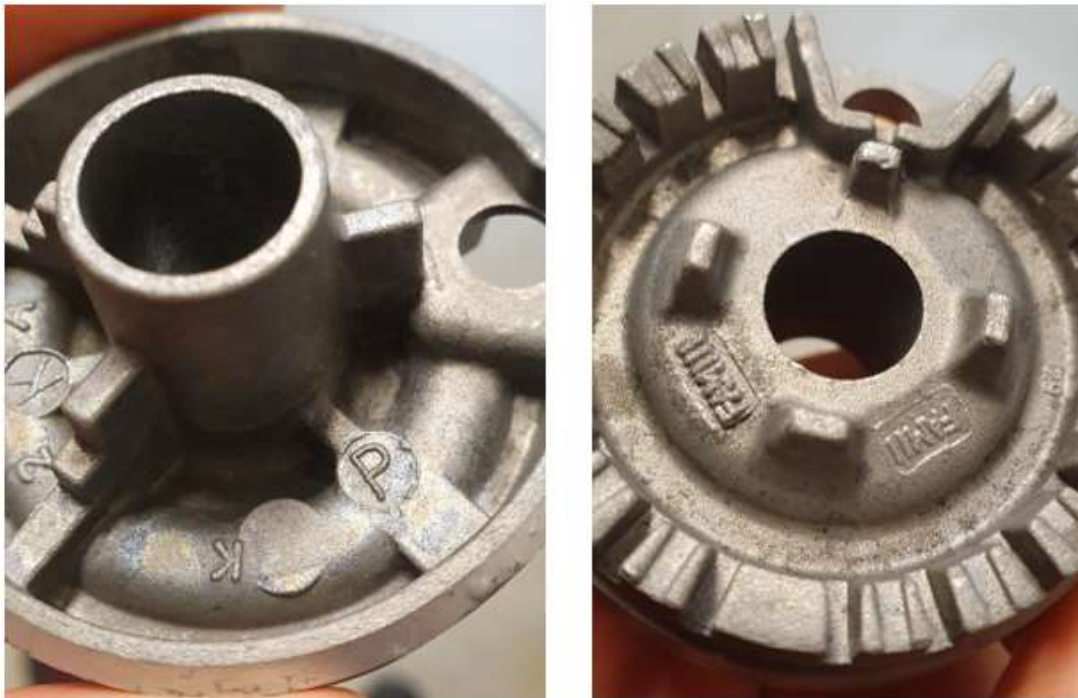
Figure 38: Pictures from cooker 1, burner D2 N°2

Overall, marks of wear can be seen, especially on the burner itself. Unidentified black marks on side and on top. This is not soot because it does not leave when touched, could it be the coating changing/reacting?

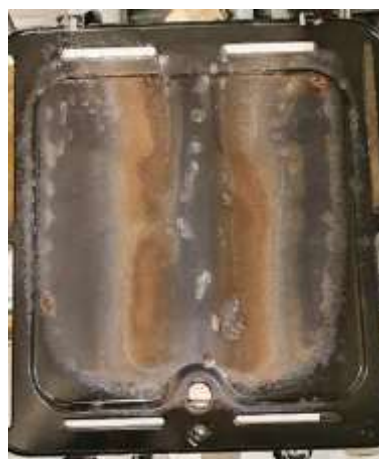
Figure 40: Pictures from cooker 1, burner D3 N°2, tray above the burners

We do notice more deposit around the burner in all the photos after the long-term test, but it has not been possible to determine what was this deposit, where it came from (some coating using elements that could react with water and form deposit?).

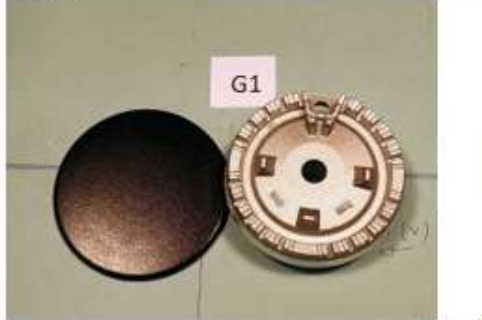
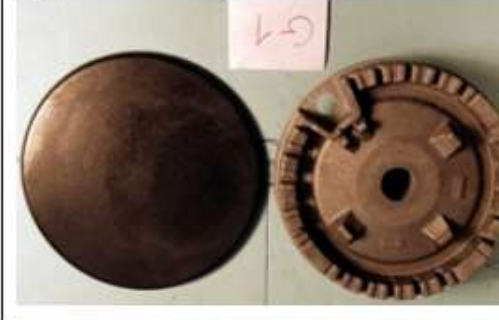
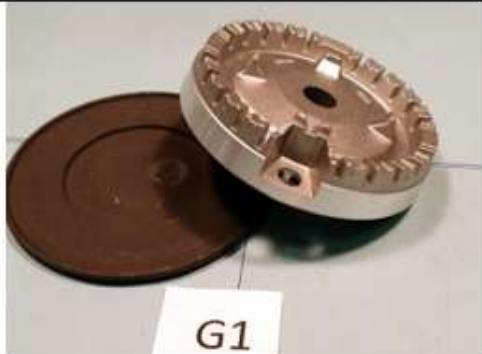
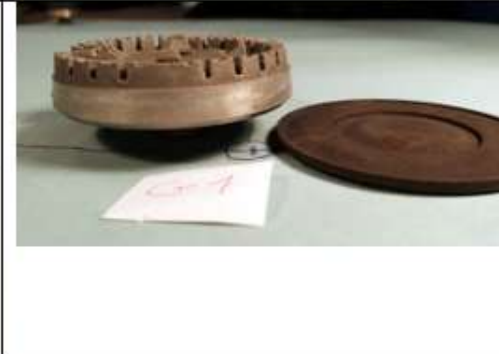
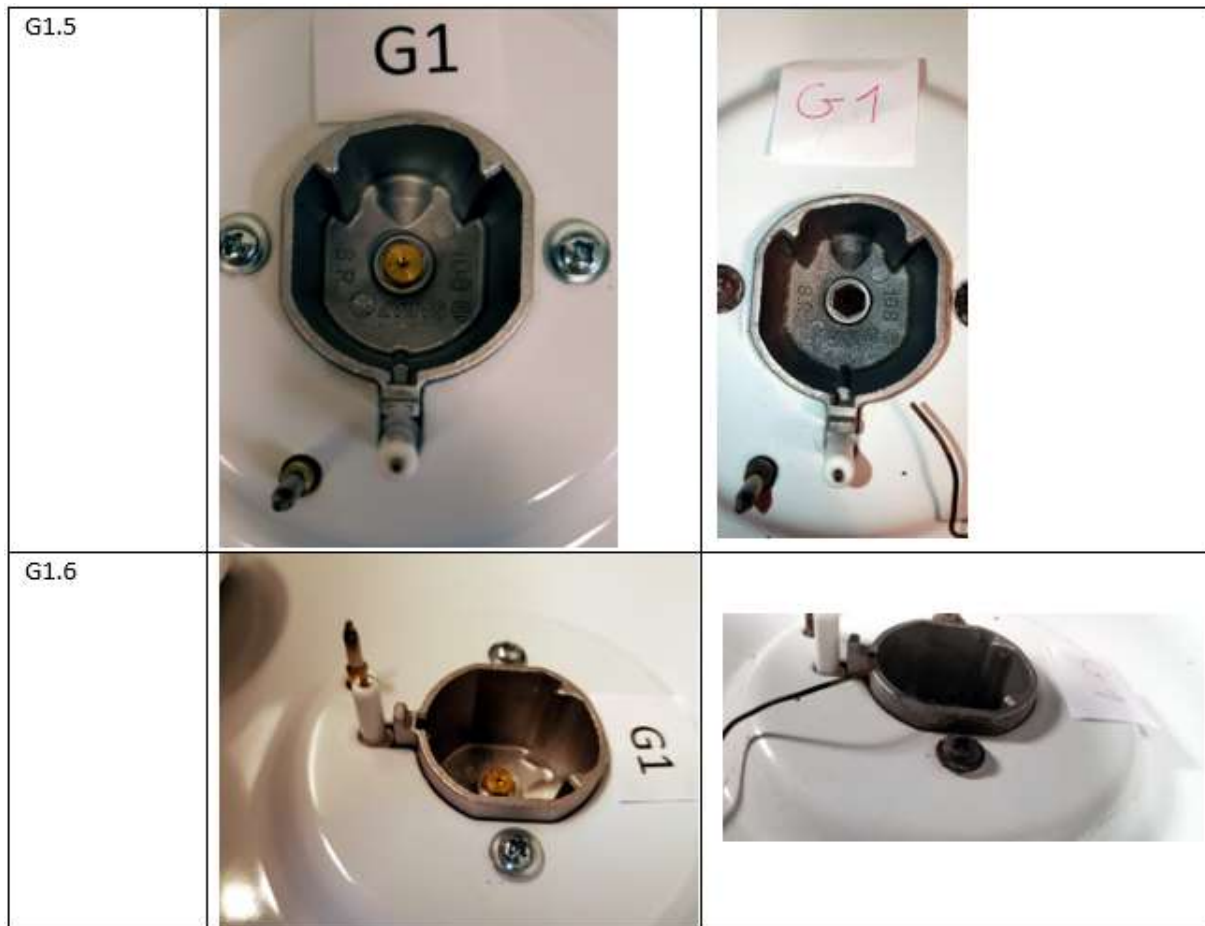
Figure 41: Pictures from cooker 1, burner G1 N°1

More deposit can be seen inside. The appearance is one of a used burner (as it would be with natural gas), especially on the sides. The deposit comes from spilled water.

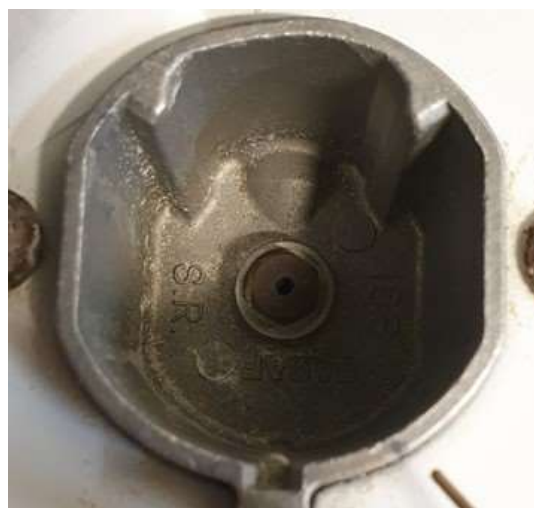
Figure 42: Pictures from cooker 1, burner G1 N°2

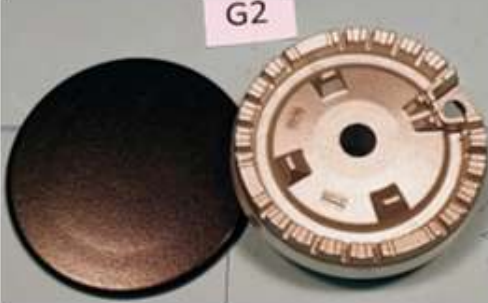
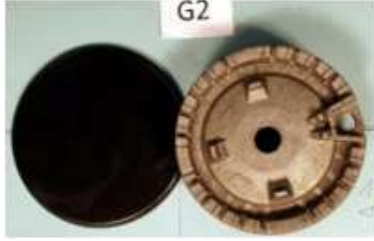
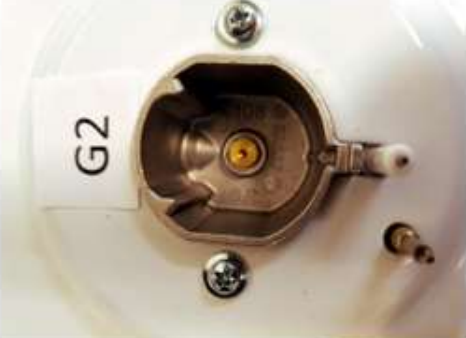
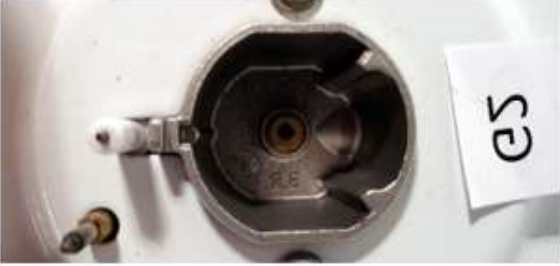
Figure: Pictures from cooker 1, burner G2 N°1

The burner just looks generally used, especially on the sides.

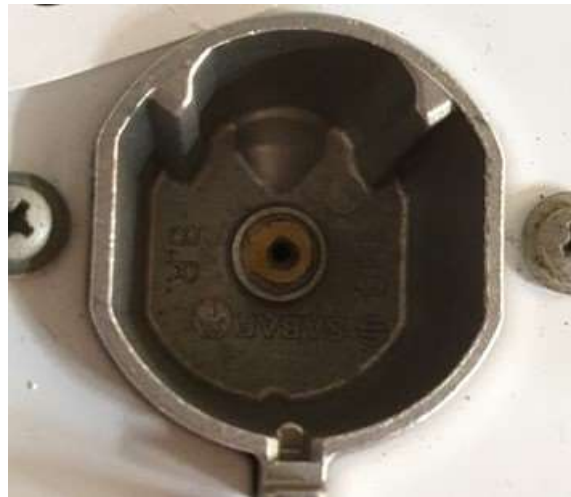
Figure 43: Picture from cooker 1, burner G2 N°2

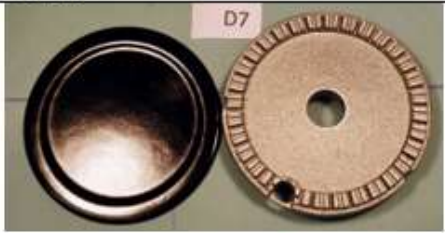
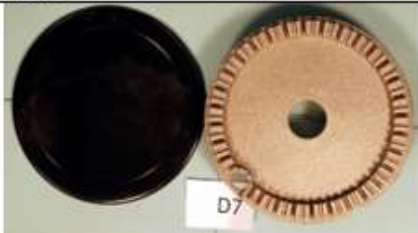
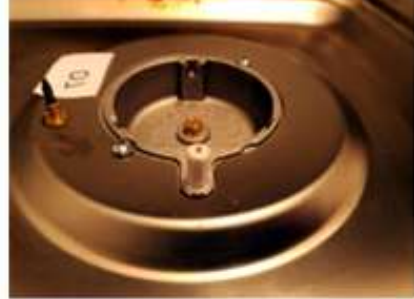
Figure 44: Pictures from cooker 2, burner D1 N°1

There is no mark of wear and tear on the burner, but some deposit in the ignition pit and we observe more rust on the bottom of the burner cap, thin white cracks (see figure above), and deposit mark on its top. Nothing out of the ordinary.

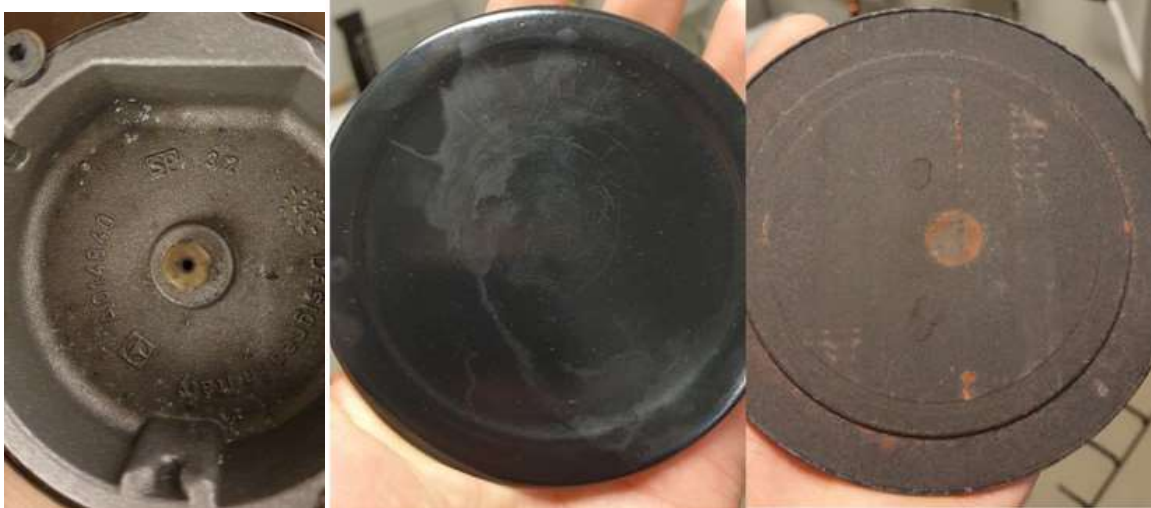
Figure 45: Pictures from cooker 2, burner D1 N°2

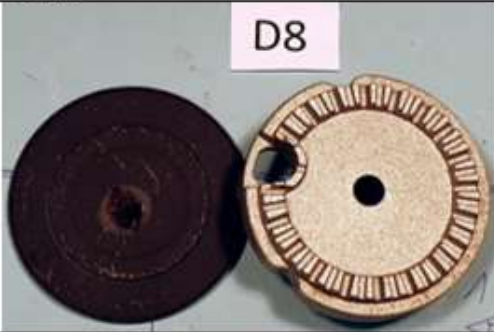
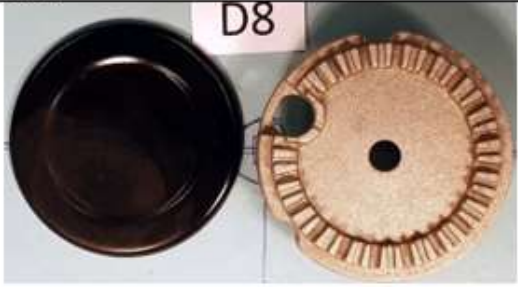
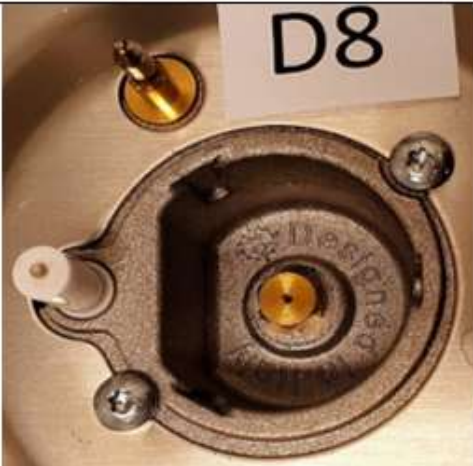
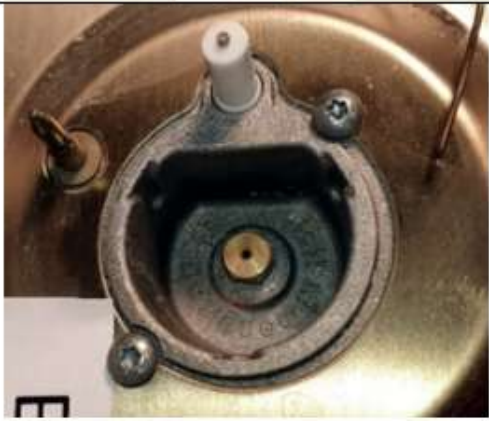
Figure 46: Pictures from cooker 2, burner D8 N°1

No mark of wear and tear on the burner, deposit in the ignition pit but there are some white traces on the burner caps.
