Testing **H**ydrogen admixture for **G**as Applications

Long term effect of H₂ on appliances tested

Report by GWI and DGC for the THyGA Consortium

Deliverable:	D3.9
Status:	Final, 10 th of May 2023
Dissemination level:	PU - Public

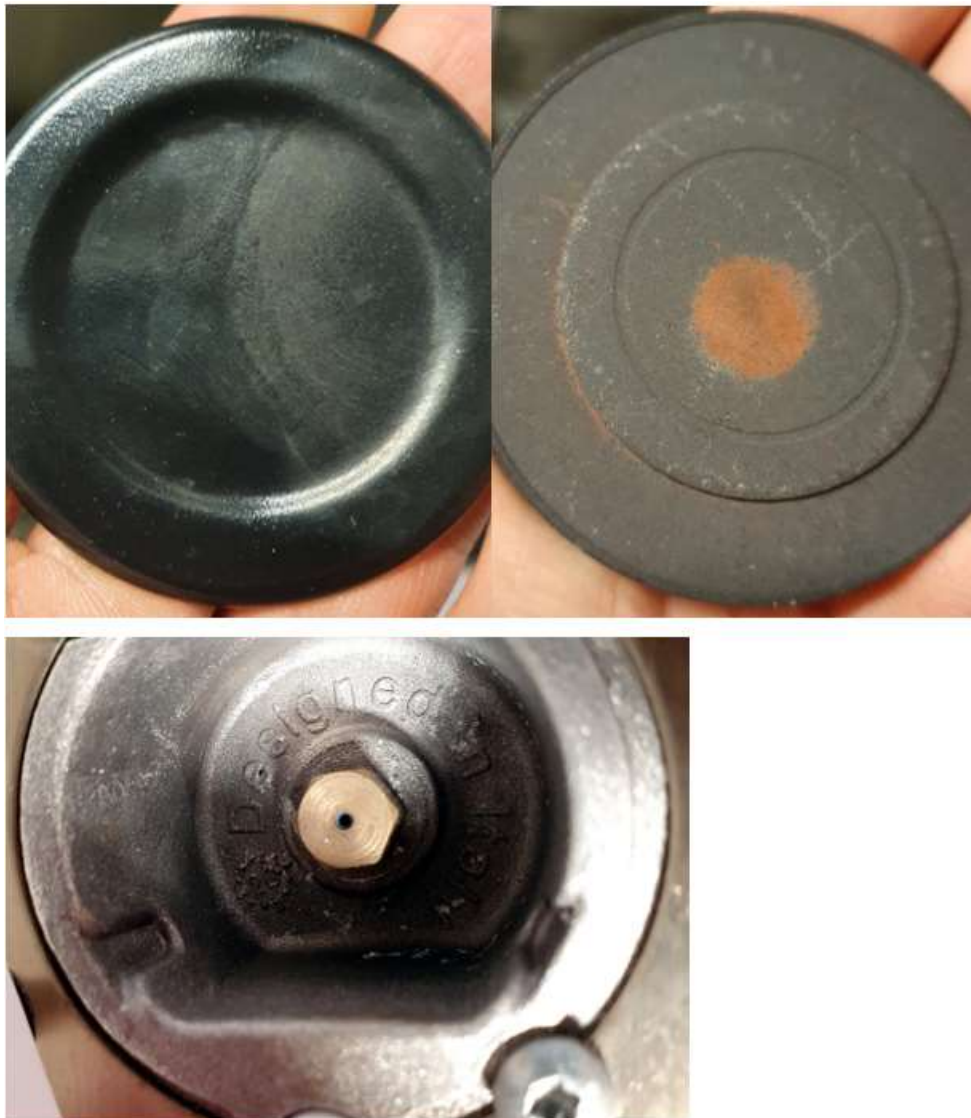
Figure 47: Pictures from cooker 2, burner D8 N°2

No mark of wear and tear on the burner, deposit in the ignition pit but there are some white traces on the burner caps.

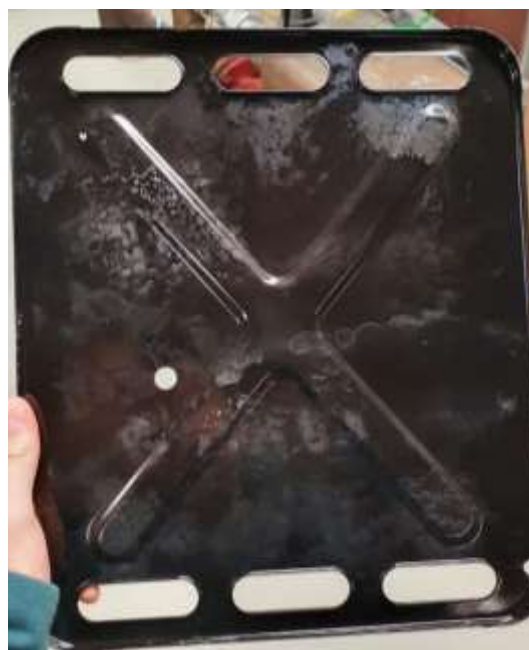
Small amount of deposit is seen, due to humidity of the combustion process but negligible.

Figure 49: Pictures from cooker 2, burner D9 N°1, tray above the burner

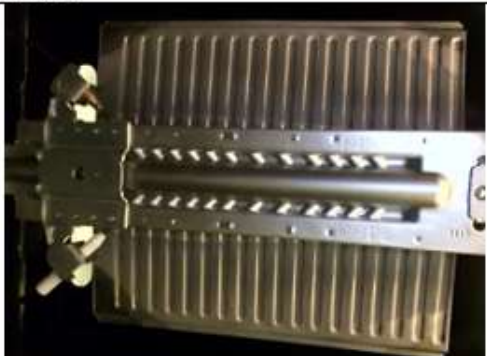
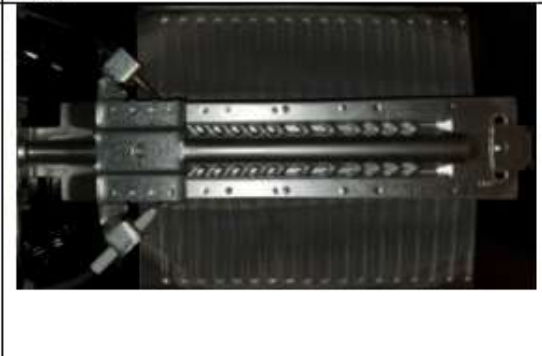
Figure 50: Pictures from cooker 2, burner D10

No sign of wear and tear, deposit on the side grills. The deposit could come from pollution in the air or dust.

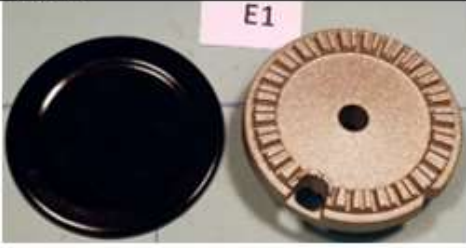
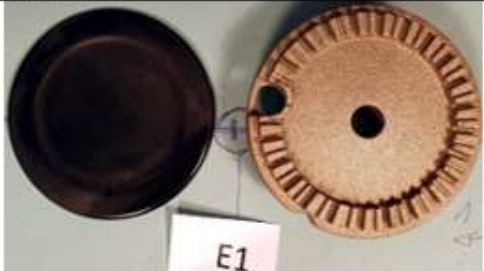
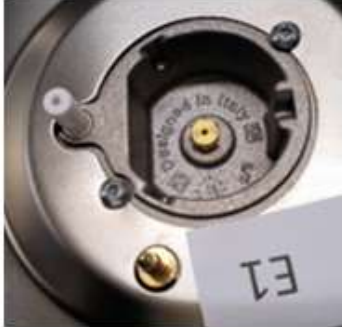
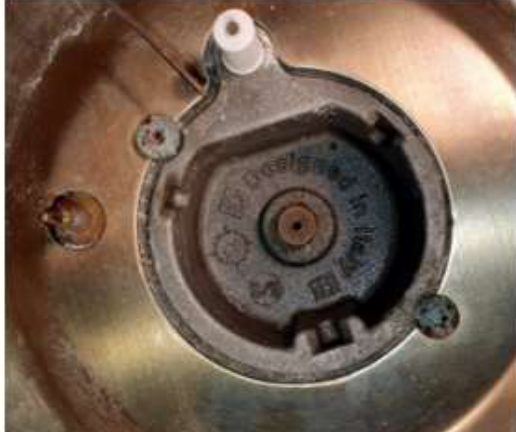
Figure 51: Pictures from cooker 2, burner E1

No mark of wear and tear on the burner, limestone deposit in the ignition pit. Deposit traces on the top side of the burner caps and more rust on the bottom side.

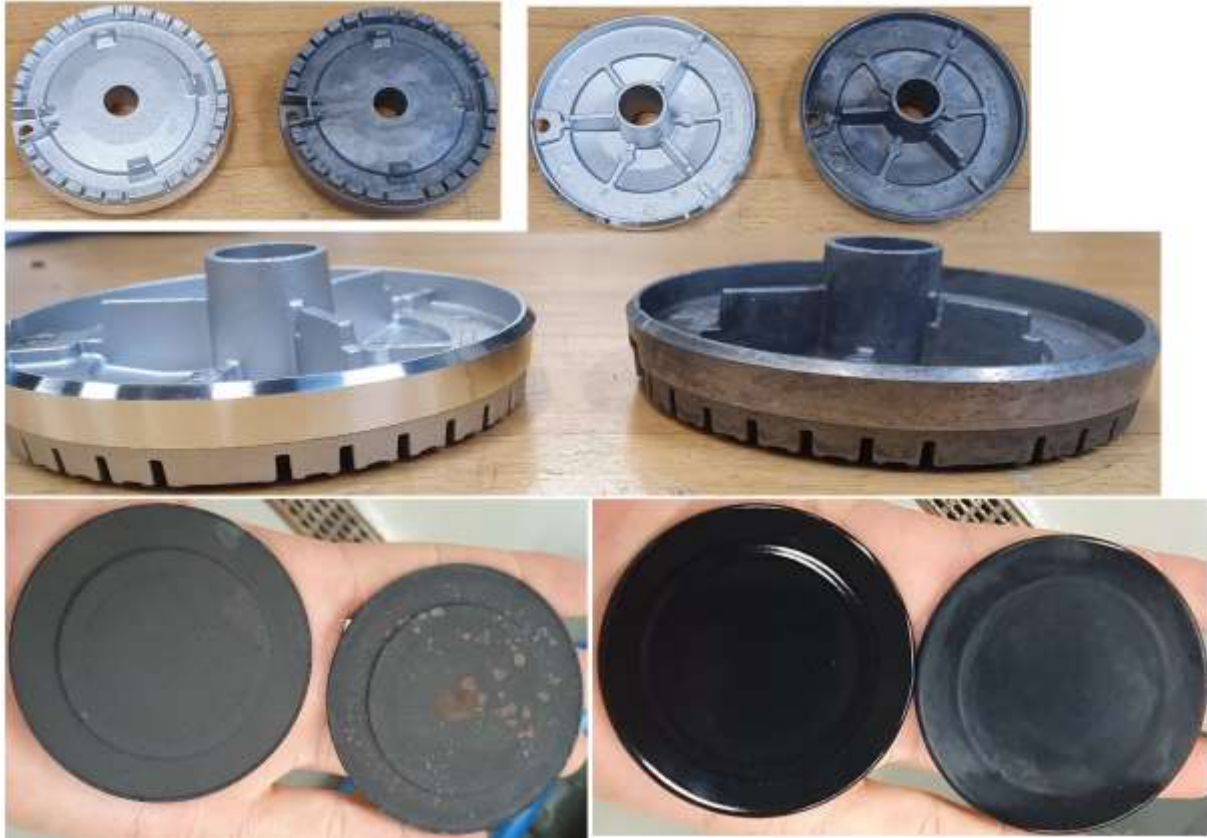
Figure 53: Comparison of parts before/after tests for cooker 1

On the left, the new parts and on the right, the used ones. We can see that there is a drastic change in color between the burners. It seems that the used one is less “grainy”. The burner cap has more rust on the bottom and deposit on top. There is no visible deformation after use.

The Cooker 1 oven shows signs of usage, in the form of black marks (not soot, it does not mark the finger) on the burners and oily reflections. The oily reflections are normal for aluminium and depend on the alloy. The black marks could come from the migration of metals inside the burner to its surface.
